Solder Reflow Failures in Electronic Components during Manual Soldering

Alexander Teverovsky, Chris Greenwell,
Frederick Felt

Perot Systems/NASA GSFC, code 562,
Parts, Packaging, and Assembly Technologies Office
Alexander.A.Teverovsky.1@gsfc.nasa.gov

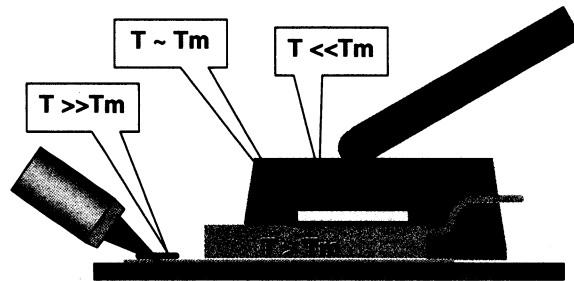
Most Probable Cause of Failure

- ☐ Manual soldering caused fast heating of the copper heat sink while MC remained cool thus forcing molten solder to create and fill top-of-die delamination.
- ☐ Fixing a part on a board by applying a force to the package increases the probability of failure.

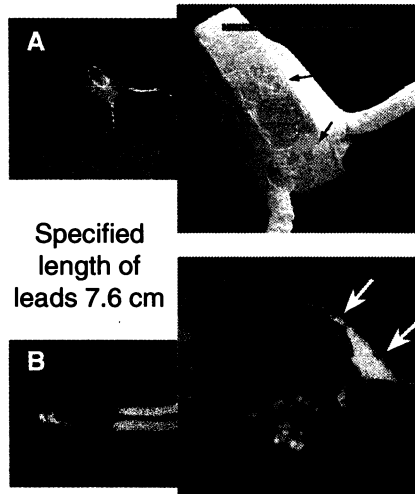
Solder Reflow Failures of Thermistors

Thermistors per 311P18-02T-7R6 passed resistance to soldering heat test MIL-STD-202, TM210.

- ☐ Case A: failed during board-level testing.
- ☐ Case B: failed after rework on the adjacent microcircuit.
- ☐ FA: short is due to solder reflow caused by overheating.

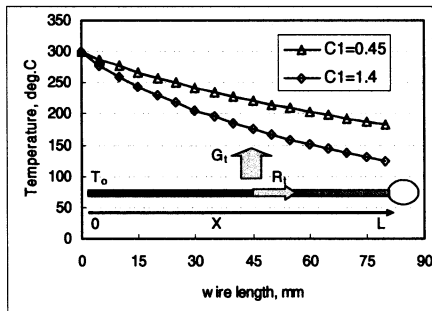
Effect of Wire Length

- ☐ At specified conditions a soldering iron is set to $T_o = 300^\circ\text{C}$ and at $L = 76\text{ mm}$ $T_{\text{sensor}} < 180^\circ\text{C}$ (no melting).
- ☐ Cutting leads to ~1" will increase T_{sensor} to 220 to 250 $^\circ\text{C}$ and might cause solder reflow failures.

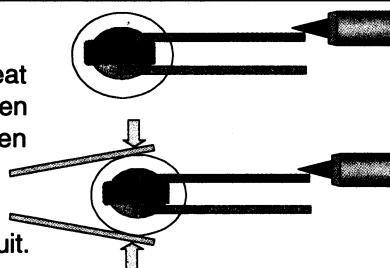
Mechanism of Failure

Case A:

Short Cu wire quickly transfers the heat to one side of the sensor forcing molten solder to expand and squeeze between cold MC and die.

Holding a sensor with tweezers increases the probability of short circuit.

Case B:

A touch with a soldering iron creates temperature gradient allowing solder melting on one side while other side remains cool.
